Accelerated Aging Test on Multiple XLPE MV Cables Simultaneously to Induce Water Trees

Abstract-

The objective of this paper is to develop an accelerated ageing test to induce water tree growth which is capable of testing up to ten 10 kV cable samples simultaneously. An existing accelerated ageing method was used as a basis for this project. This method uses a high frequency power supply (3 kHz) to achieve a test duration of 14 days. Modifications were made to this method to allow for multiple samples to be tested simultaneously. A specially designed variable inductor was utilised in a parallel RLC resonance circuit. This resonance circuit limits the current draw from a high frequency high voltage transformer which allows for up to ten sample to undergo the test.

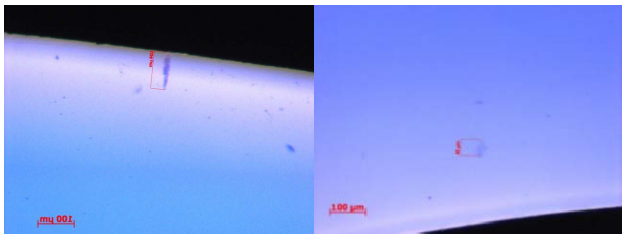
Fig. 1 Sample 2 Images- Vented Tree (Left), Bow-Tie Tree (Right)

From Table I above, it can be seen that samples 3, 6, 8 and 10 were found to have no trees of any kind whereas, there were at least one type of tree found in the remaining samples. Sample 1 exhibited the second largest bow-tie tree and vented tree. The largest vented tree was recorded in sample 2 which can be seen in the left image in Fig. 1 below. Sample 5 was found to have the largest bow-tie tree and the largest quantity of bow-tie trees. The lowest concentration of trees in a sample where tree were discovered was found to be sample 9. Further analysis of these results are discussed in the next section.

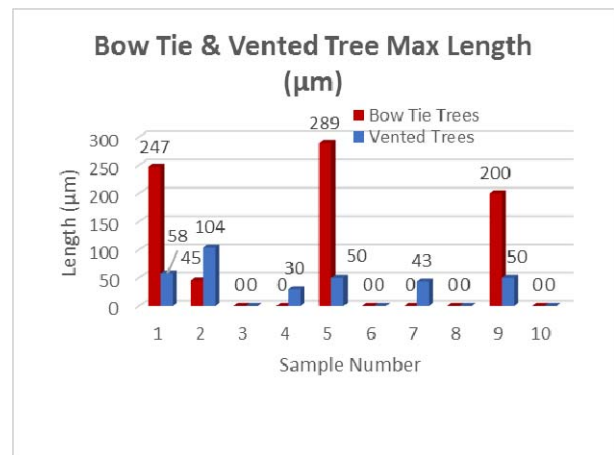
Fig. 2 Max Length: Bow-tie Vs Vented Trees

As can be seen in Fig. 2, a total of 6 cables have developed water trees.

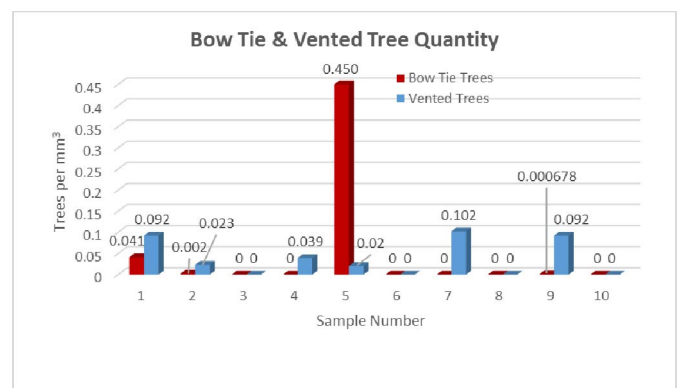
Fig. 3 Quantity: Bow-tie Vs Vented Trees

As shown in Fig. 3 below, it can be seen that only four cables were found with bow-tie trees.

From Fig. 3 it can be seen that vented trees occur more often. This is likely due to imperfections on the surface of the semi-conductive layers, where vented trees can originate from. However, the large quantity of bow-tie trees in sample 5 suggest strong contamination in the manufacturing process of this cable.

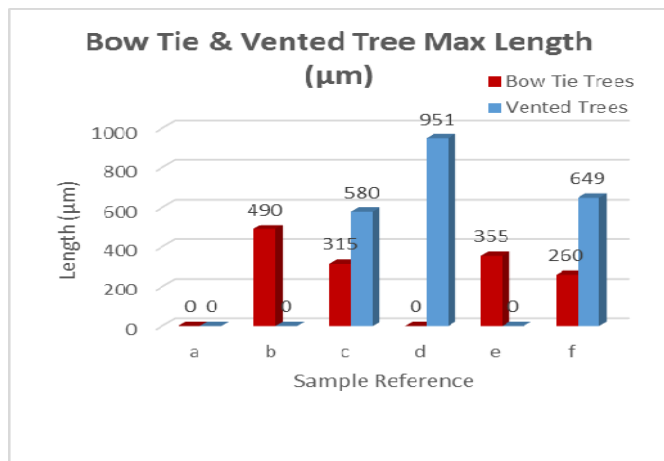
Fig. 4 Results for previous accelerated ageing tests. (2013)

Comparing these results with results from the previous 3 kHz accelerated ageing test carried out by the utilities company, can give an indication on whether or not resistance to water tree growth has improved in recent years. Fig. 4 shows the results of a test carried out in 2013.

The samples in Fig. 4 are different cables than were tested for this project. However, a trend of both large vented and large bow-tie tree can be observed. One of the most notable points to take from this graph is the length of the vented trees. These vented trees are up to 9 times larger the current vented trees. The average maximum length of tree Fig. 4 were found to be 300 μm whereas the average maximum length of trees for this report were found to be 55.8 μm . This would suggest water tree resistance has improved overall especially in the case of vented trees.
